**NASA CR-159739
EDR 10085**

PLASMA-SPRAYED DUAL DENSITY CERAMIC TURBINE SEAL SYSTEM

FINAL REPORT

**DETROIT DIESEL ALLISON
DIVISION GENERAL MOTORS CORPORATION
INDIANAPOLIS, INDIANA 46206**

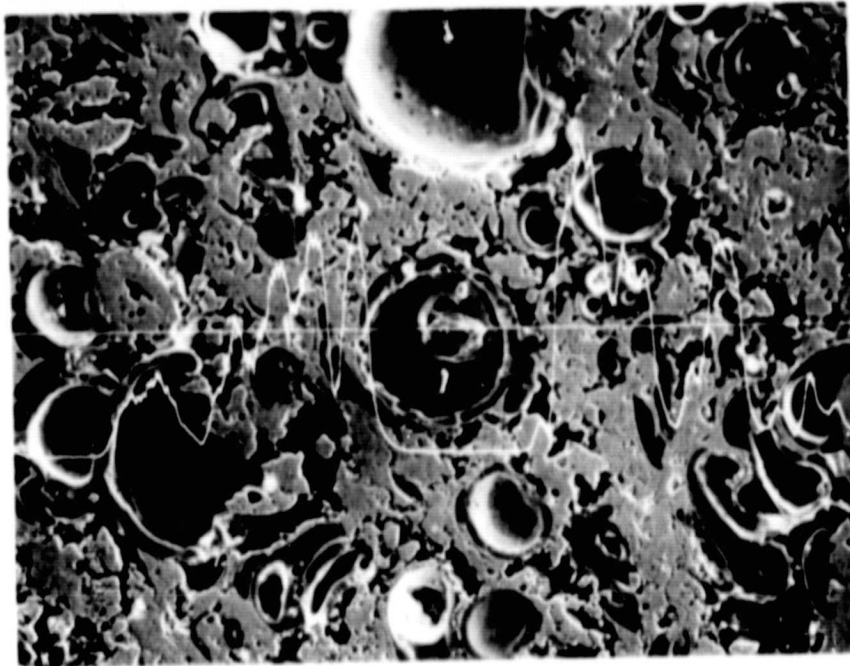
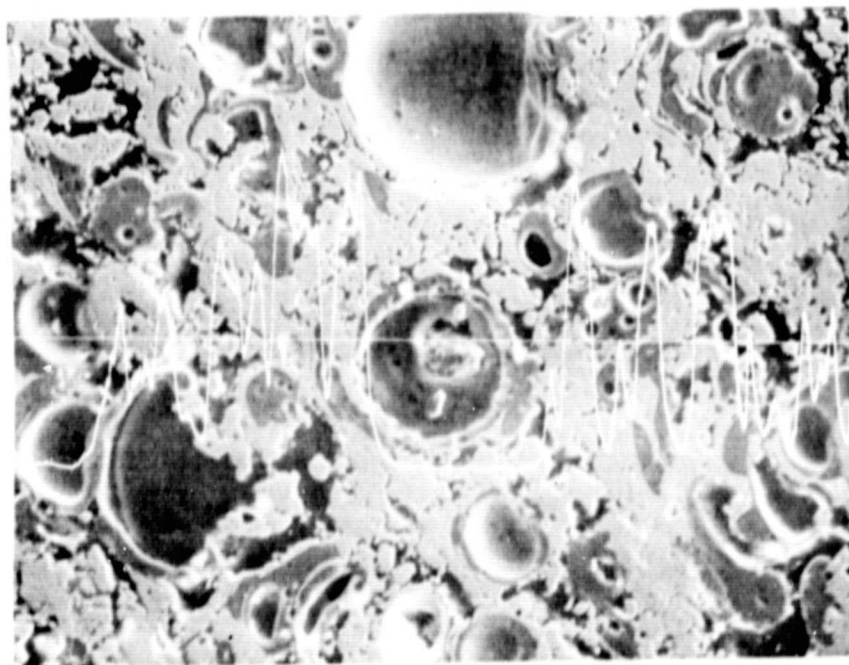
a. Elemental zirconium analysis

b. Elemental yttrium analysis
